## EVALUATION OF WATER QUALITY AND SUSTAINABLE MANAGEMENT STRATEGIES FOR VARTHUR LAKE, BENGALURU

### Abstract

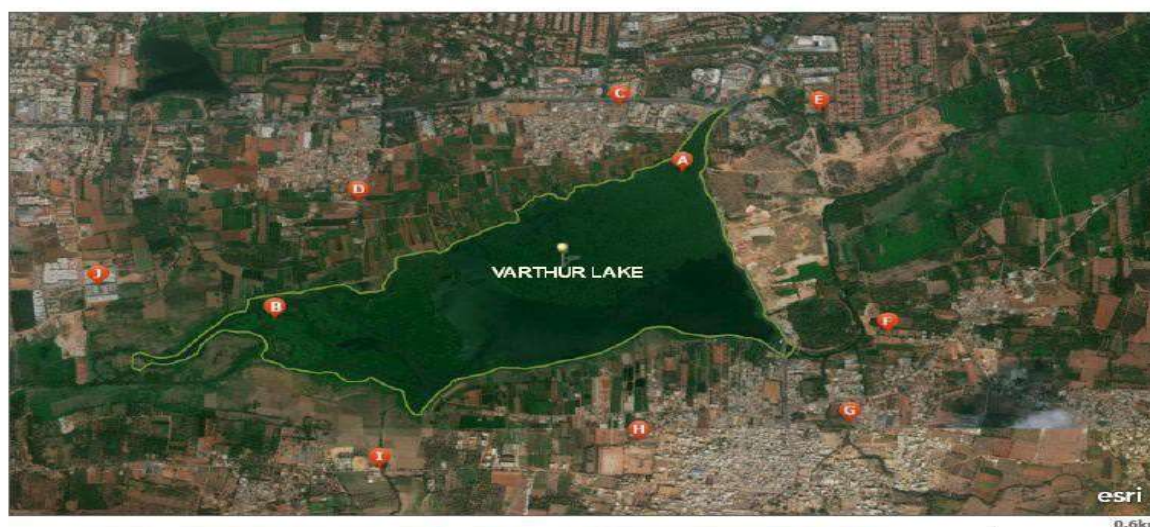
Figure 3: Samples locations of the study area in Pre monsoon (April 2018)

Field investigations and sample collection were conducted to ensure a comprehensive representation across the entire study area (refer to Fig. 2 and Fig. 3). Sampling locations were strategically selected to provide an even spatial distribution and capture variability in water quality across the lake and surrounding areas. The latitude and longitude coordinates of each sample location are detailed in **Table 1** for precise geographical reference. This systematic approach facilitates a robust analysis of water quality parameters across the study area.

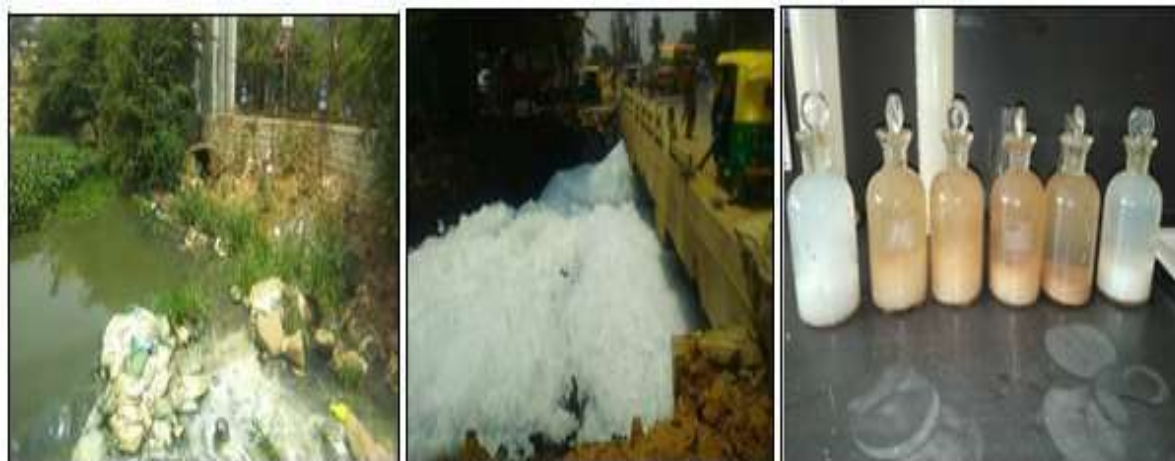
Several visual observations were documented during the field investigation, providing direct evidence of the lake's deteriorating condition. The water exhibited a **sandy coloration**, accompanied by a **foul odor** and the presence of **foam** on the surface (refer to Fig. 4). These indicators highlight the significant levels of contamination and organic pollution affecting Varthur Lake. Such observations underscore the urgent need for effective intervention and restoration measures.

**Fig.4 photos of lake and water samples**
